VEHICLE ACCIDENT INVESTIGATION

CASE NO. 90-13

TECHNICAL REPORT

1. Report No.	2. Government Accession No.	3. Recipient's Catalog No.	
4. Title and Subtitle Vehicle Accident Investigation NCSI Case No. 90-13		5. Report Date ██████████ 1991

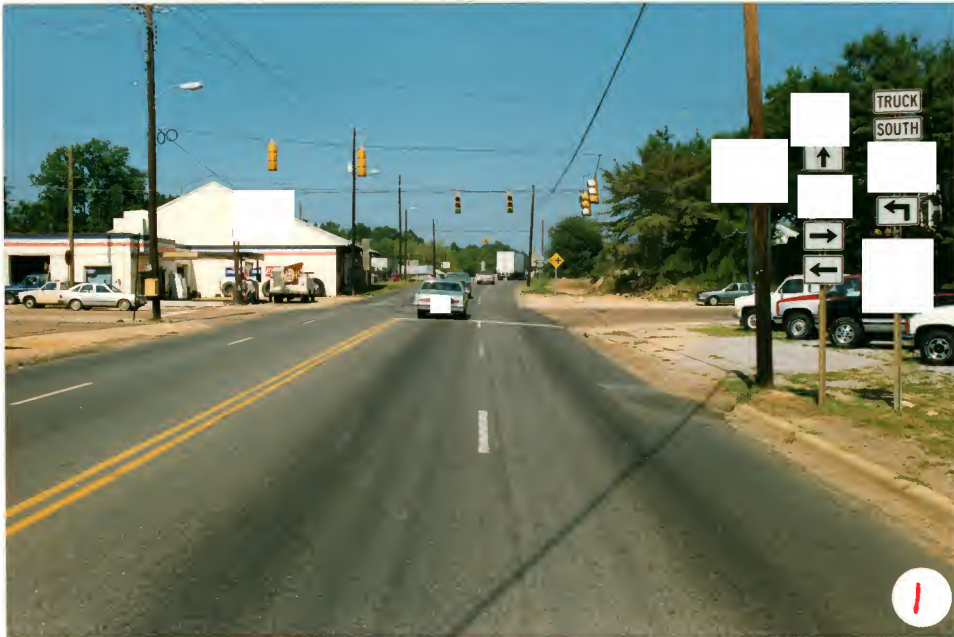
1. Pre-impact direction of travel of the Chevrolet Caprice (airbag vehicle), west on U.S. Route

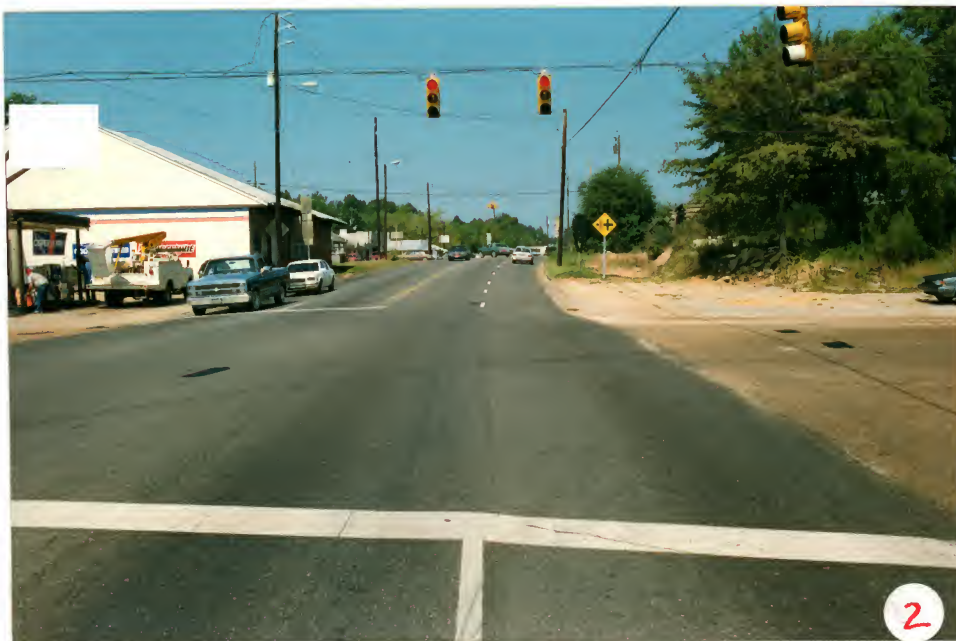
2. The Caprice enters the intersection with Alabama

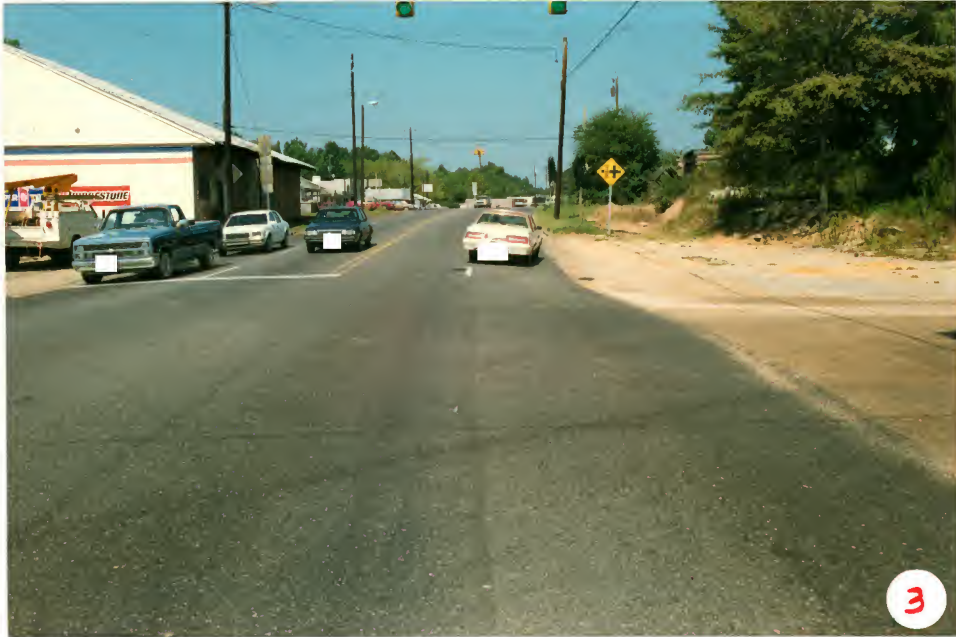
3. Area of impact between the airbag vehicle and vehicle #2.

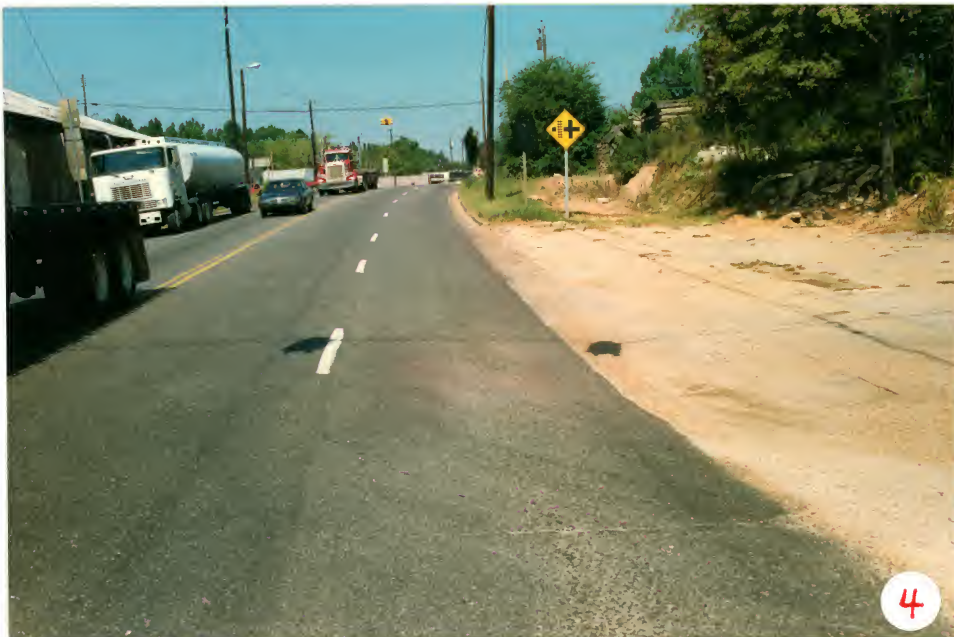
4. Final rest area of both vehicles.

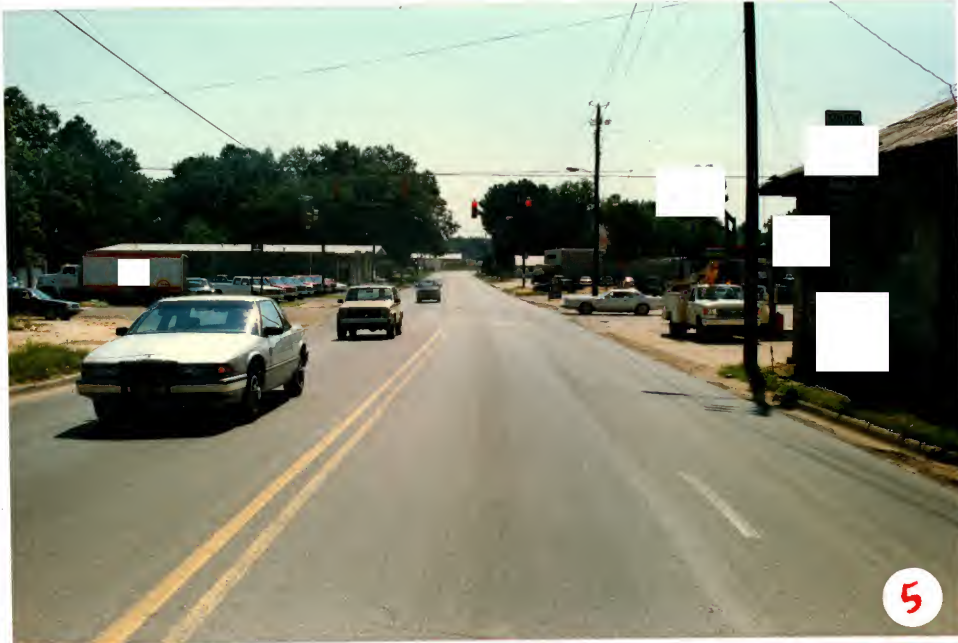
5. Pre-impact travel of the Chevrolet Blazer (vehicle #2), east on U.S. Route

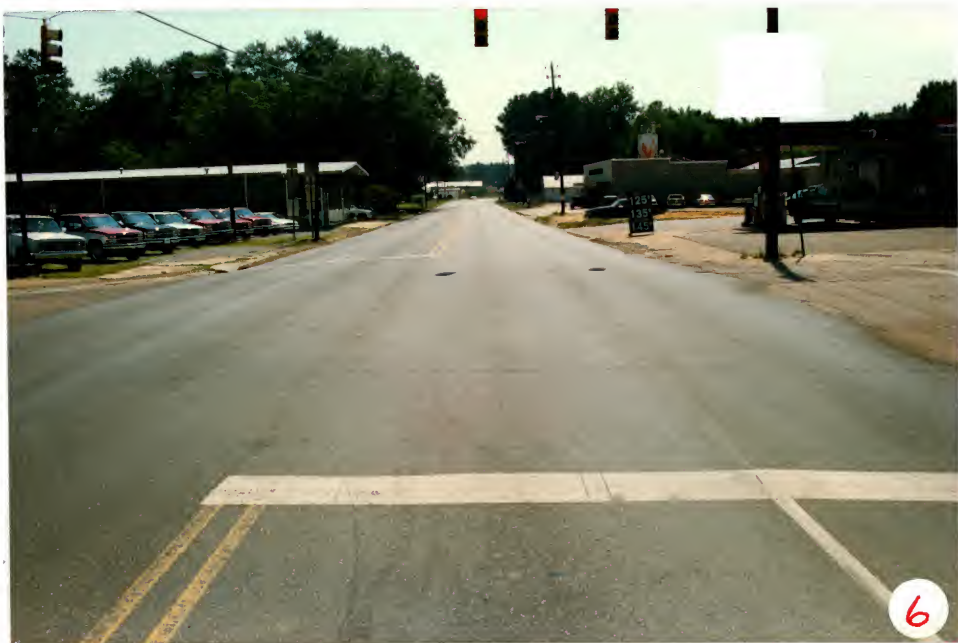
6. Vehicle #2 attempts a left turn to travel north on Alabama

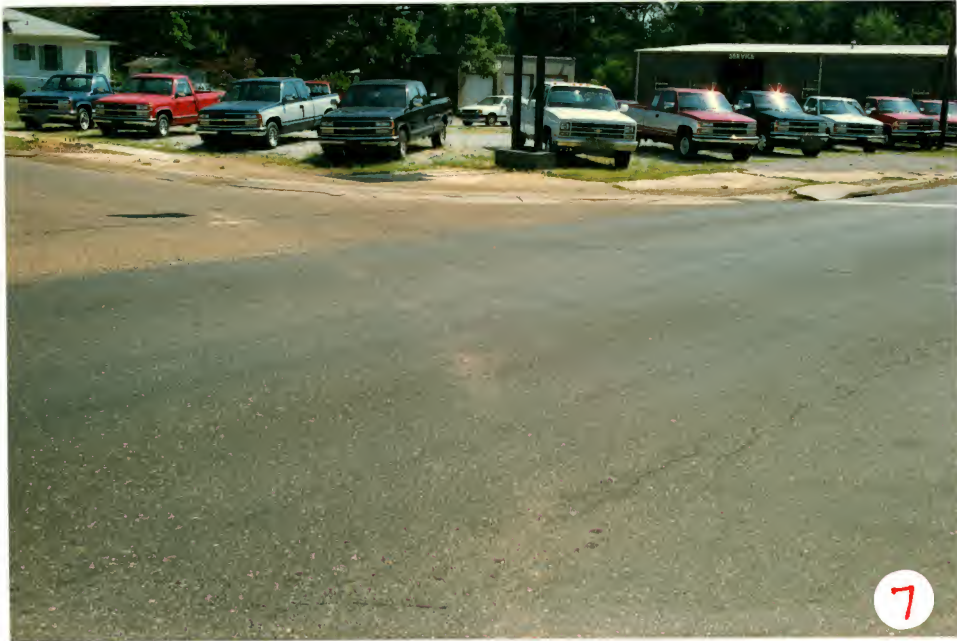
7. Area of impact between vehicle #2 and the airbag vehicle.

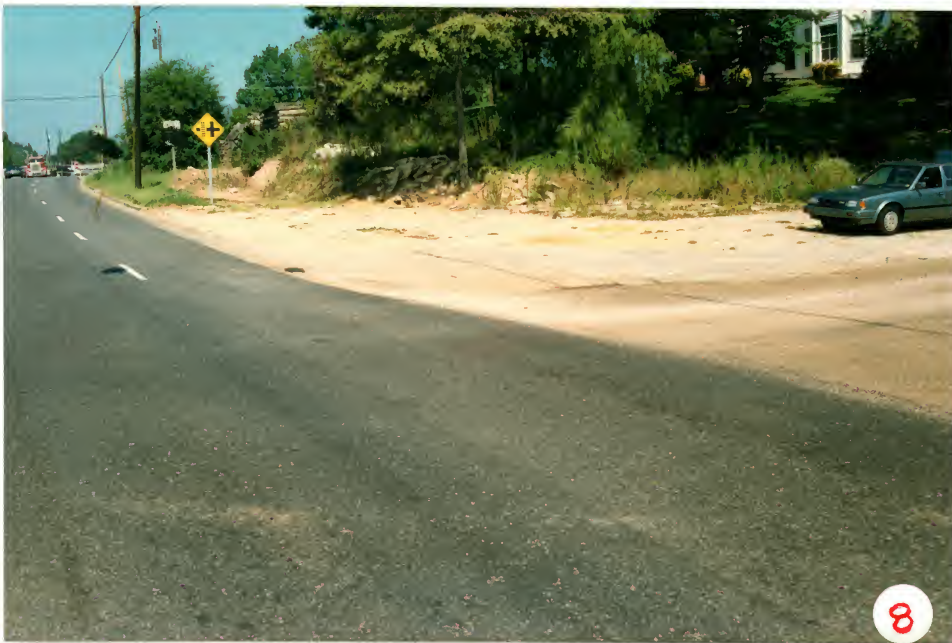
8. View from the impact area looking toward the final rest area of both vehicles.

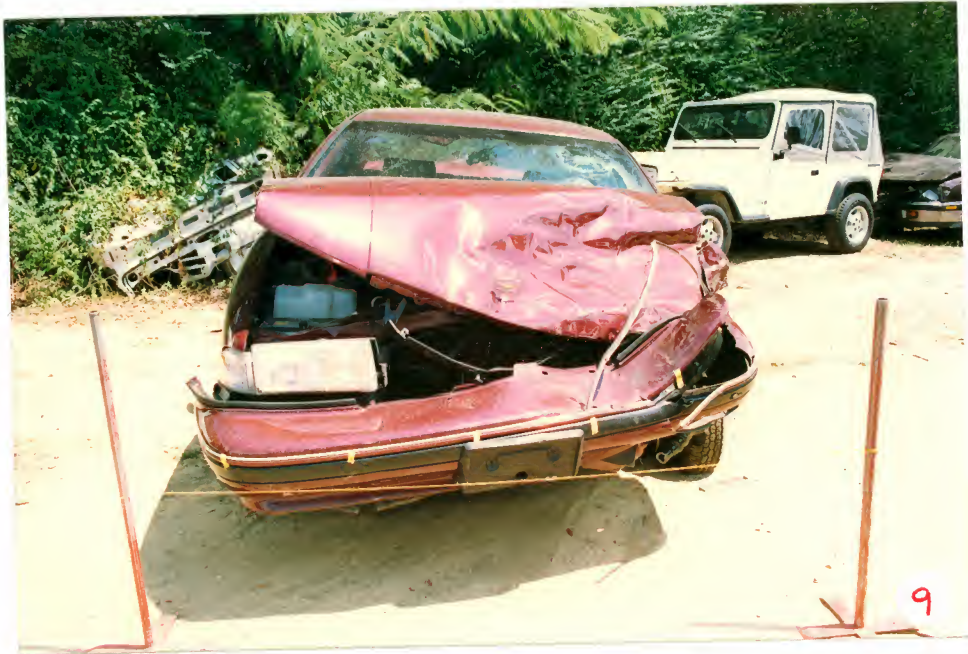
Exterior:	<p>The front left corner of the airbag vehicle contacted the front of vehicle #2. Direct impact damage extended 42 inches across the frontal plane of the vehicle. The most significant crush was located at the front left corner with the bumper displaced rearward 17.5 inches. Impact damage extended beyond that point to include the rearward displacement of the front wheel assembly. A CDC of 11-FYEW-2 was assigned to the impact damage. Crush dimensions measured along the bumper were as follows:</p> <p>C1 = 17.5" C2 = 15.0" C3 = 9.25" C4 = 9.0" C5 = 3.0" C6 = 1.0"</p> <p>Damaged components included the front bumper, hood, grille, radiator, left front fender, left front wheel assembly, left front door, roof, windshield, left floor pan, numerous engine components, etc.</p>	<p>The front of vehicle #2 contacted the front left of the airbag vehicle in a head-on impact configuration. The vehicle sustained direct damage across the entire front bumper. Crush measurements were estimated from damaged parts since the bumper was removed before the vehicle was inspected. A CDC of 01-FDEW-2 was assigned. Estimated crush dimensions are as follows:</p> <p>C1 = 2.0" C2 = 4.0" C3 = 6.0" C4 = 12.0" C5 = 8.0" C6 = 6.0"</p> <p>Damaged components included the front bumper, radiator, grille, hood, left and right front fenders, frame rails, windshield, etc.</p>

9. Frontal view of the airbag vehicle showing the damage sustained in the collision.

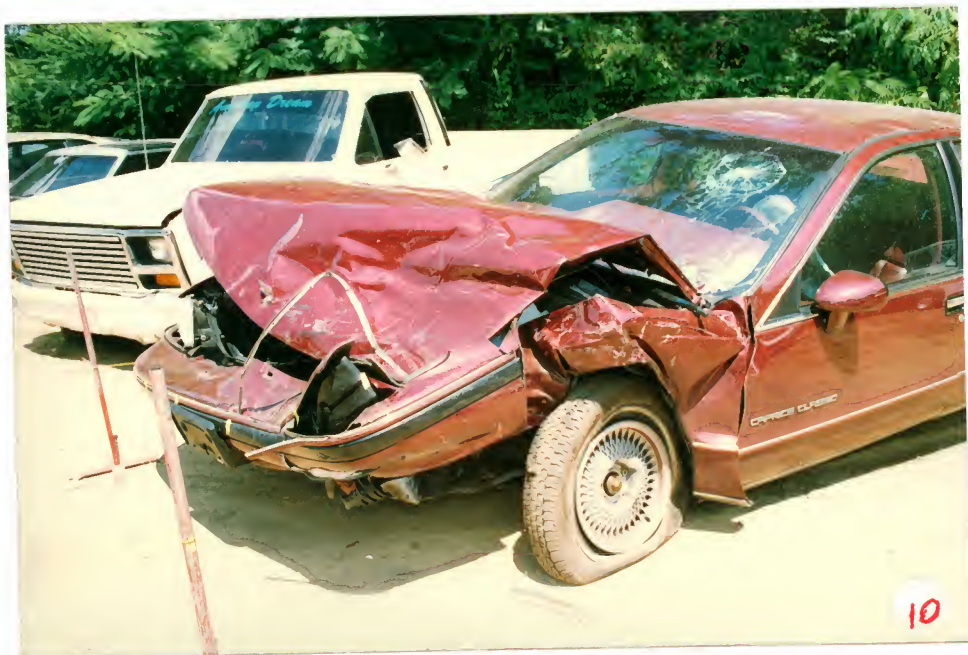
10. Left front view of the vehicle showing damage from the impact with vehicle #2.

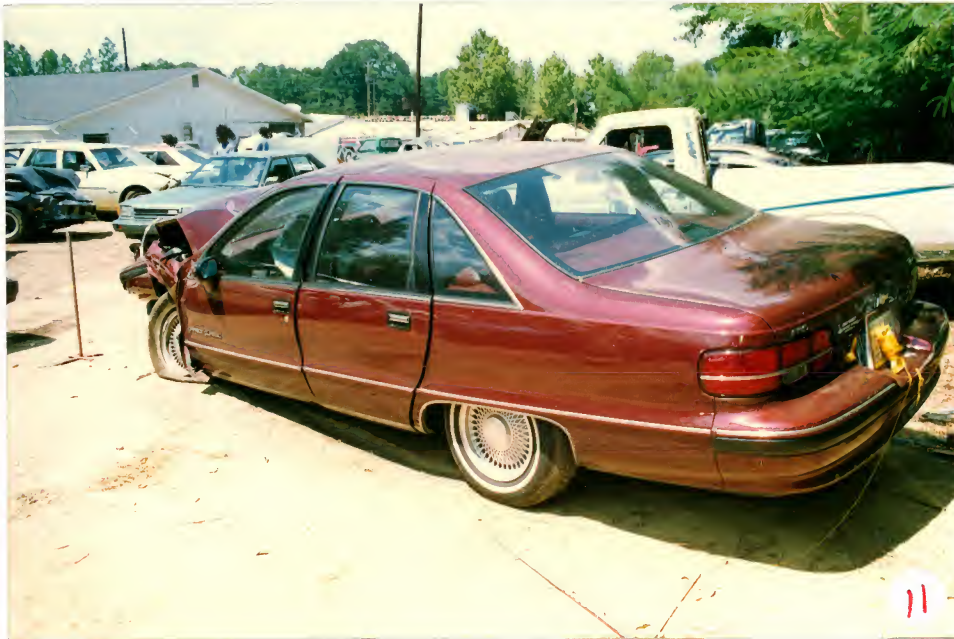
11. Left rear three-quarter view of the Caprice.

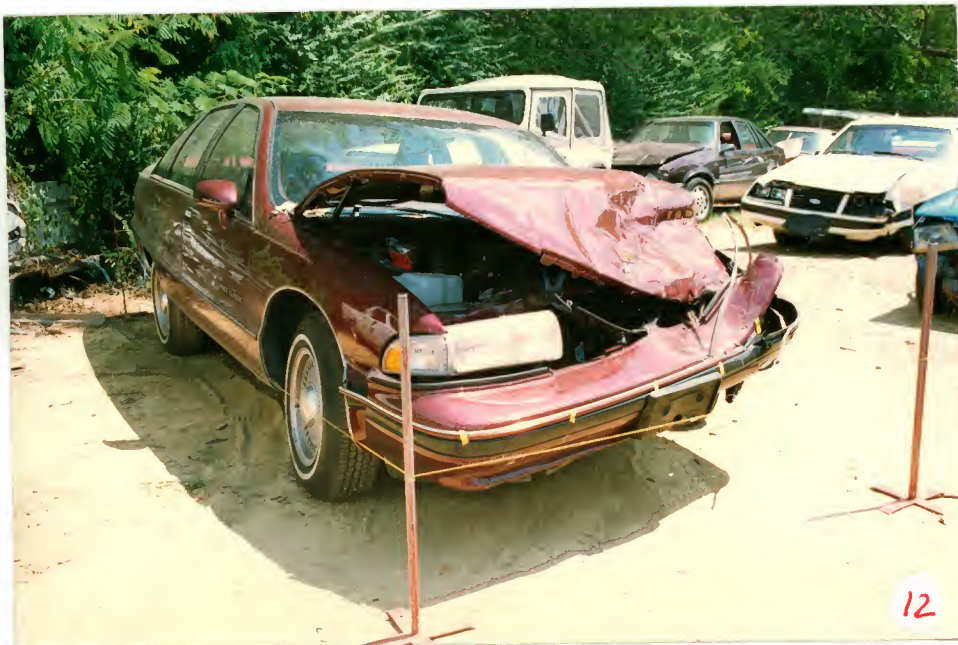
12. Right front three-quarter view of the vehicle.

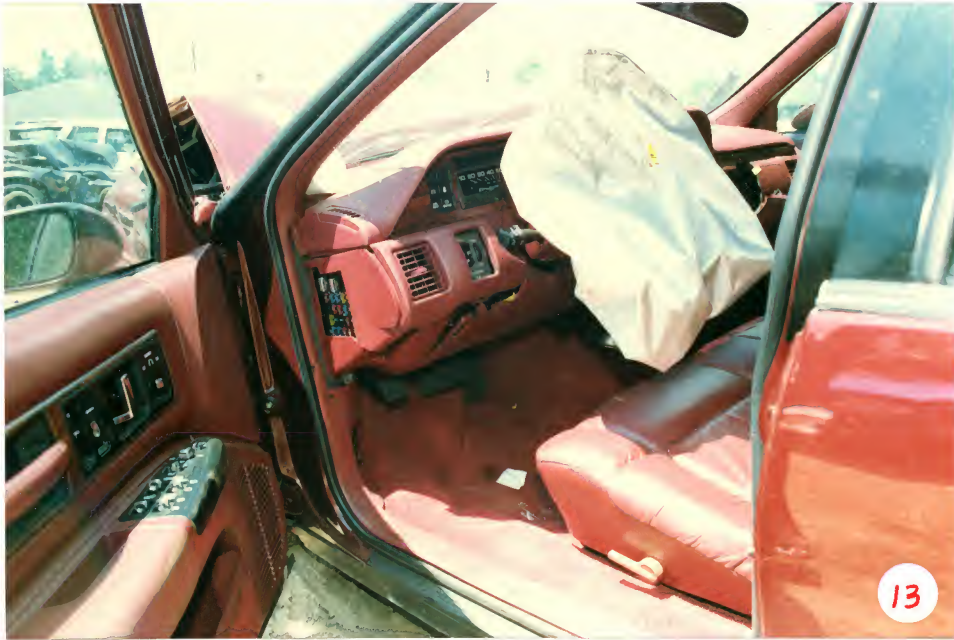
<u>Airbag Vehicle</u>	<u>Vehicle #2</u>
CDC:	11-FYEW-2	01-FDEW-2
Repair Cost:	\$18,900.00	Unknown
Interior:	<p>Interior damage resulted from the airbag deployment, occupant contact and intrusion from exterior damage.</p> <p>Airbag deployment resulted in separation of the steering wheel cover at the designated perforations. The airbag remained intact without any tears or cuts noted. Only a small smudge (blood) was found on surface of the deployed airbag.</p> <p>Occupant contact resulted in interior damage to the lower left instrument panel, rear view mirror, windshield and the glove box. Both the driver and right front passenger contacted the vehicle's interior during the impact.</p> <p>Approximately 1 inch of intrusion was noted to the left side floor pan. The left front wheel was displaced rearward into the floor pan resulting in this intrusion.</p>	<p>Vehicle #2 sustained interior damage as a result of occupant contact. Damage was observed to the steering wheel, lower left instrument panel and windshield. No other interior damage was noted.</p>

13. Interior view showing the deployed airbag and occupant contact to the lower left instrument panel.

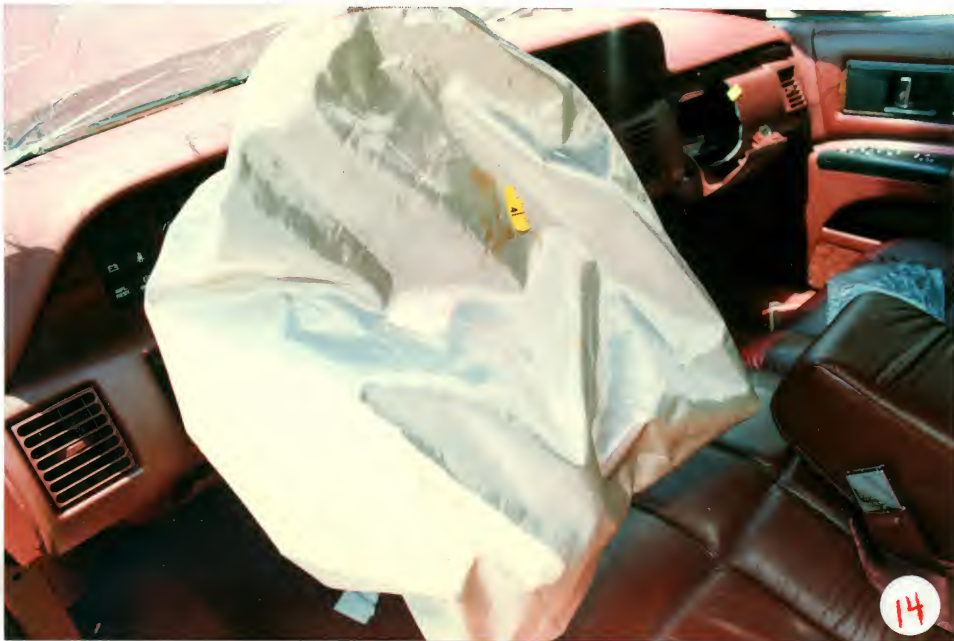
14. Close-up view of the deployed airbag showing possible occupant contact.

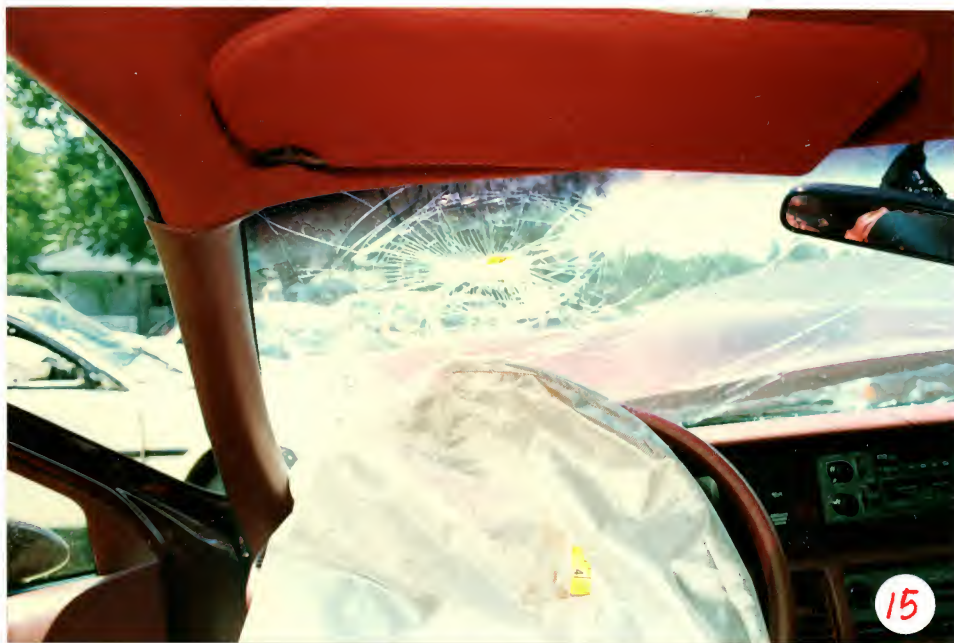
15. View of occupant contact to the deployed airbag and the windshield.

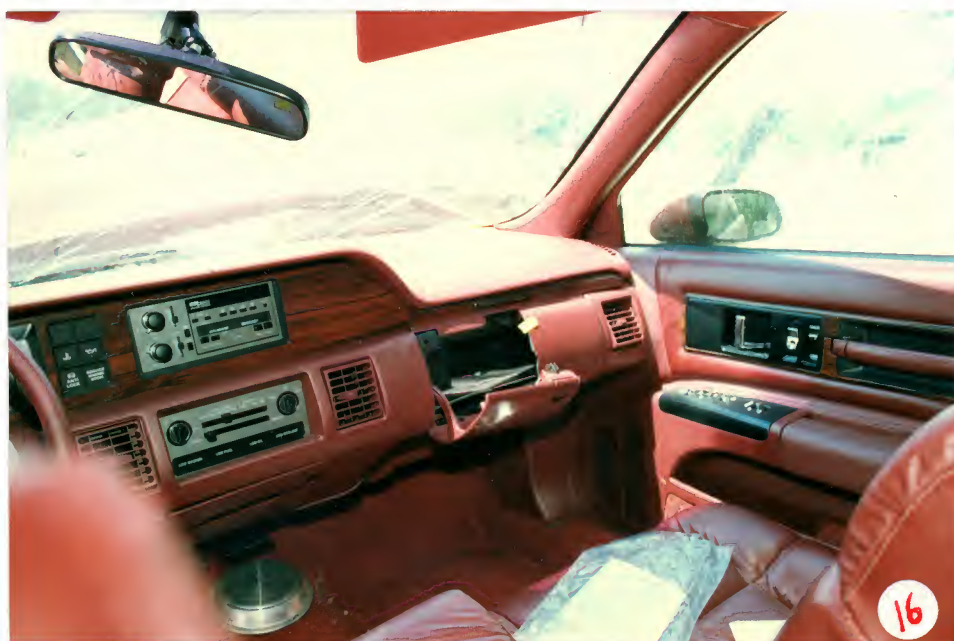
16. Interior view showing possible occupant contact to the rearview mirror and glovebox.

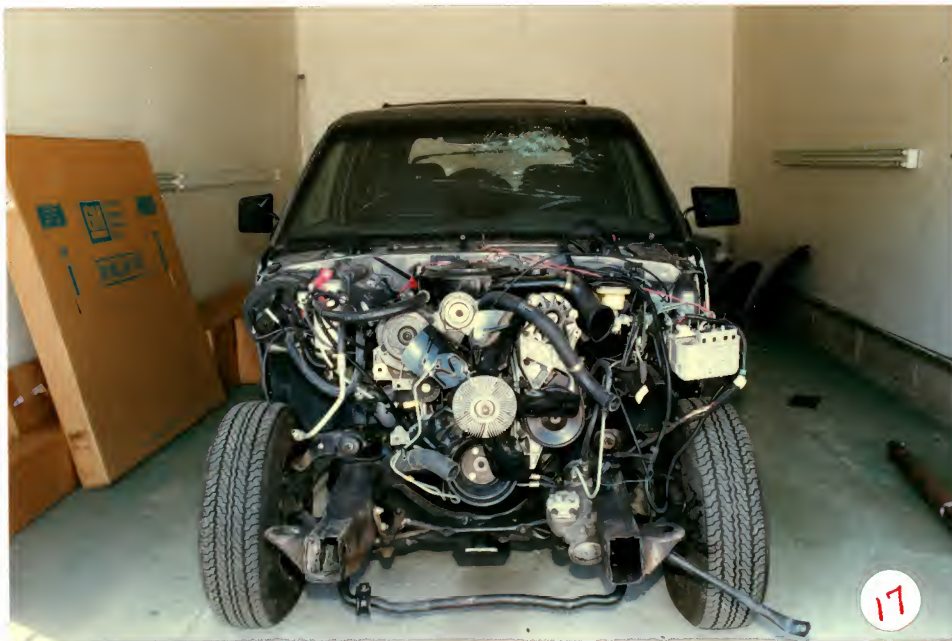
17. Frontal view of vehicle #2 while under repair.

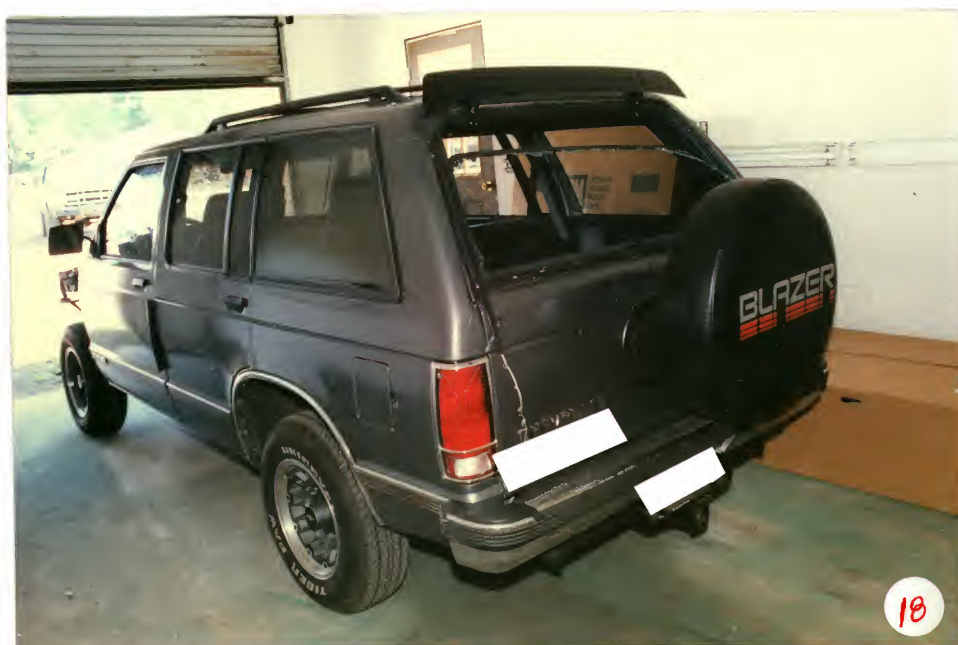
18. Rear view of vehicle #2.

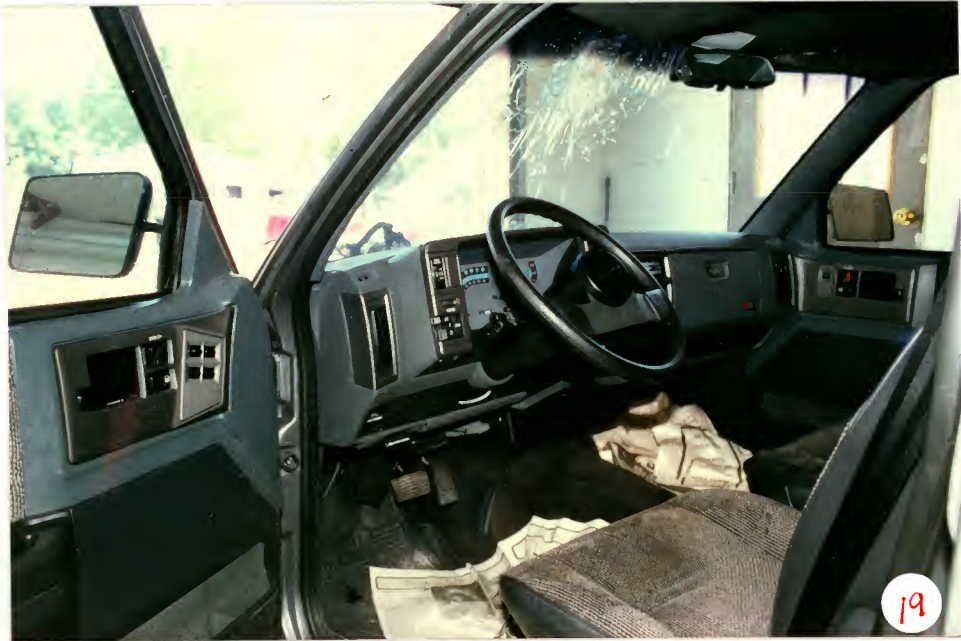
19. Interior view of vehicle #2 showing occupant contact to the windshield and steering wheel.

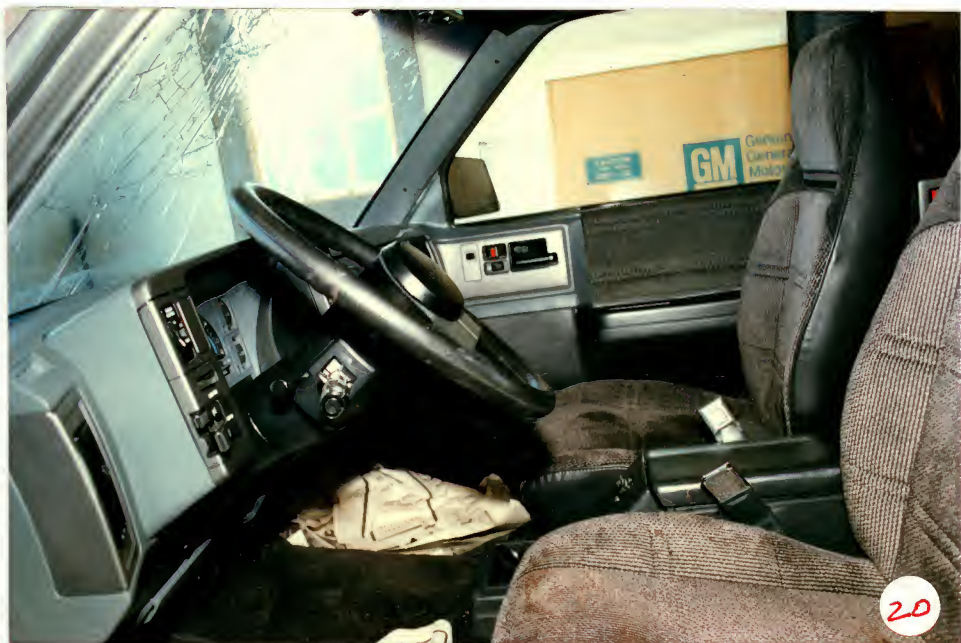
20. Interior view of vehicle #2 showing deformation to the steering wheel rim from occupant contact.
